Helicopter safety offshore

**OFFSHORE TECHNOLOGY REPORT
2000/089**

Graham Morrison
Offshore Division
Hazardous Industries Directorate
Health and Safety Executive
Lord Cullen House, Fraser Place
Aberdeen AB25 3UB
Scotland
United Kingdom

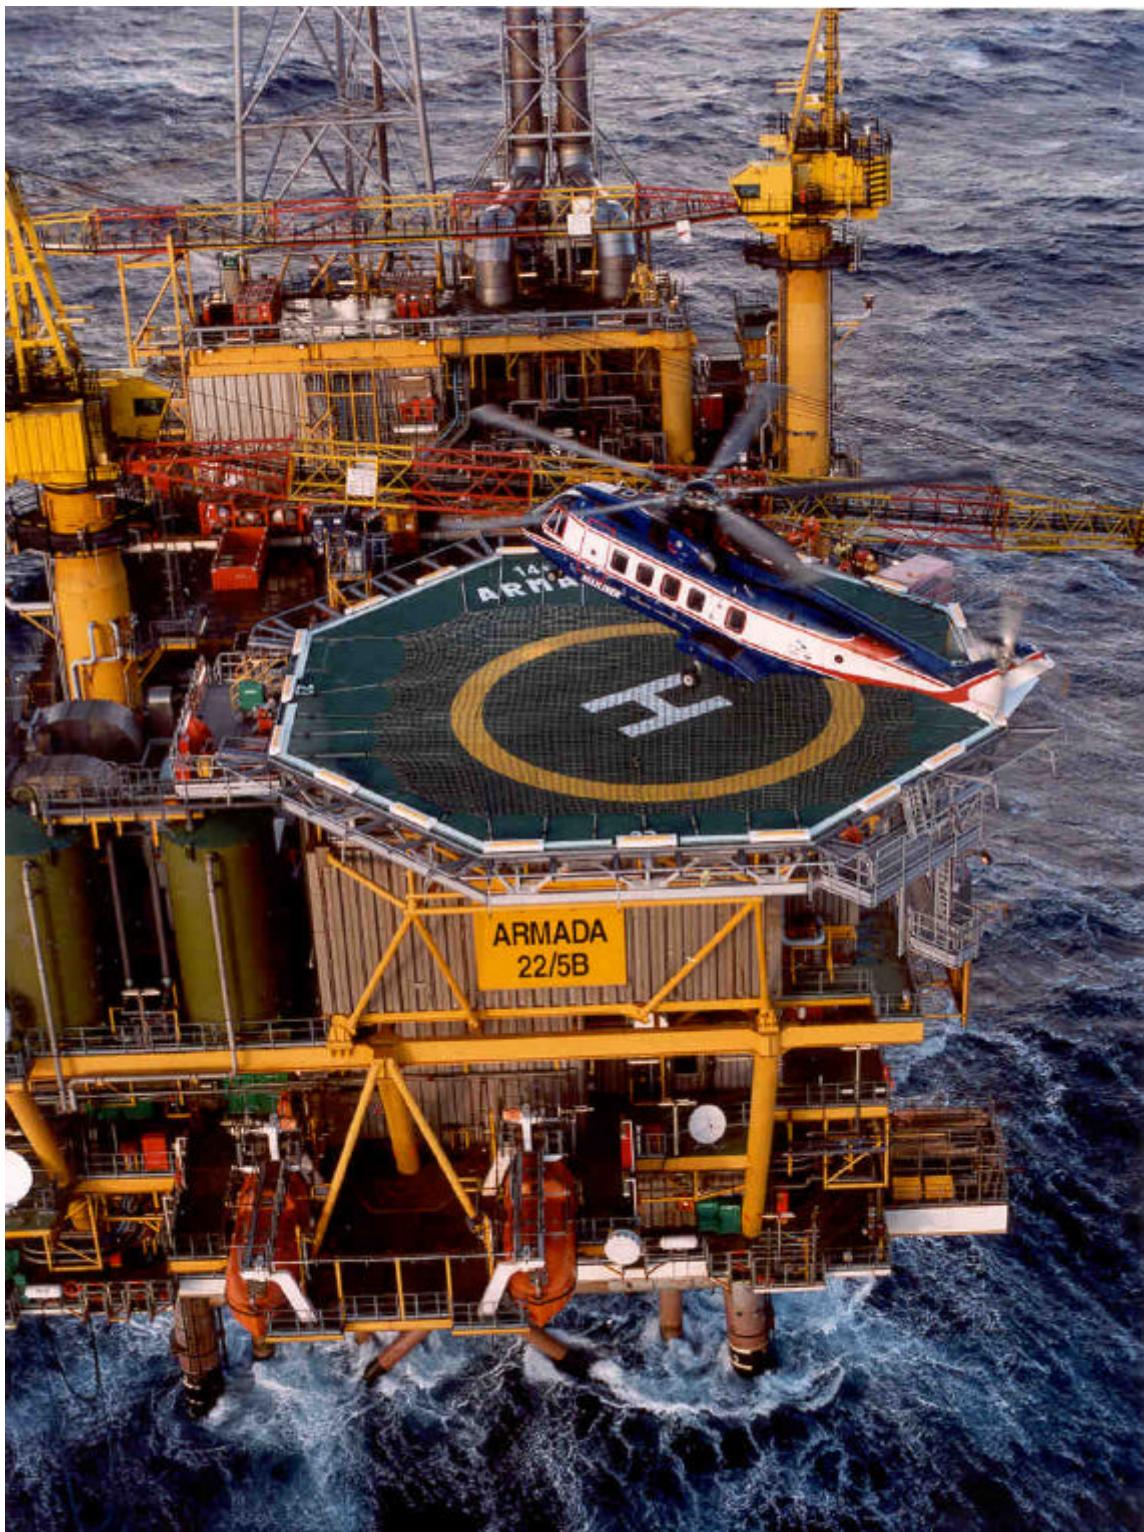
Figure 1: EH101 helicopter landing on a fixed platform
(photograph courtesy of European Helicopter Industries Ltd)

Risks are assessed both to people travelling to offshore installations by helicopter during take-off, while in flight and landing, and from helicopter accidents while they are on an installation. Figure 1 shows a helicopter coming in to land on a fixed installation.

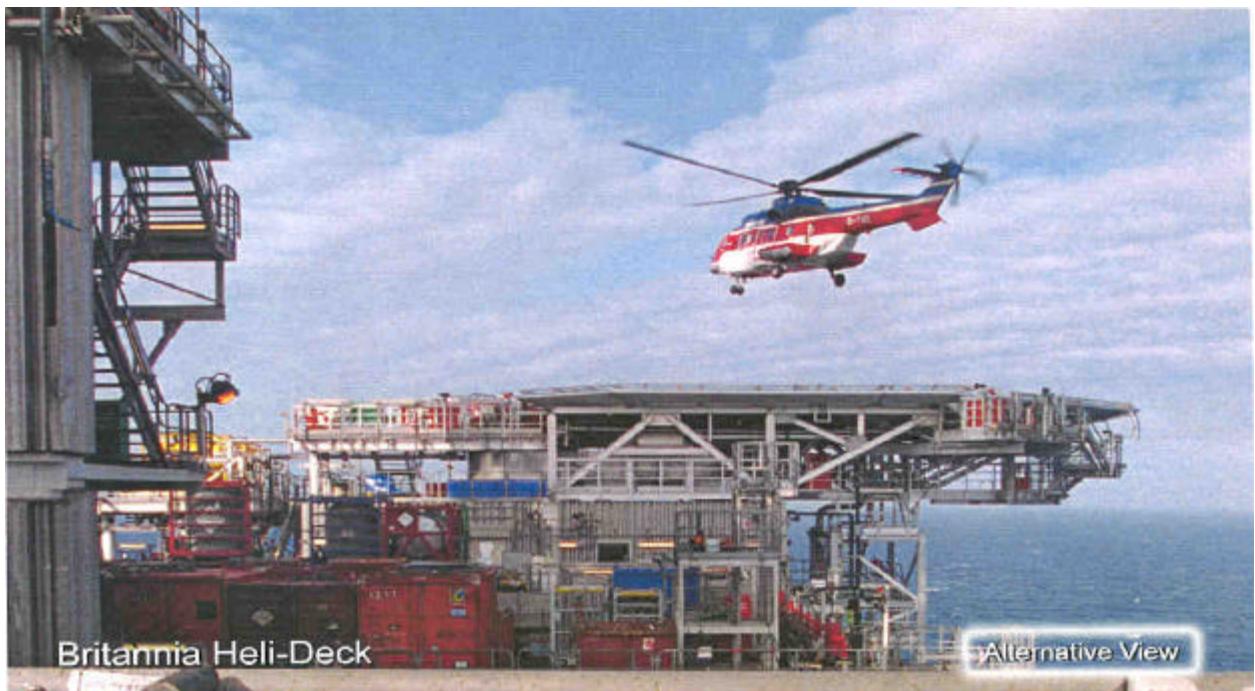
Figure 2: Super Puma landing on a fixed platform
(photograph courtesy Britannia Operator Ltd)

An offshore helideck is normally made of steel or aluminium (though a few fire-protected timber helidecks still remain on older platforms in the southern North Sea). The helideck is usually located above the accommodation module and raised on steel trusses to allow clear air to flow under the deck. Sometimes the helideck is offset from the accommodation on a cantilevered truss structure as shown in Figure 2.

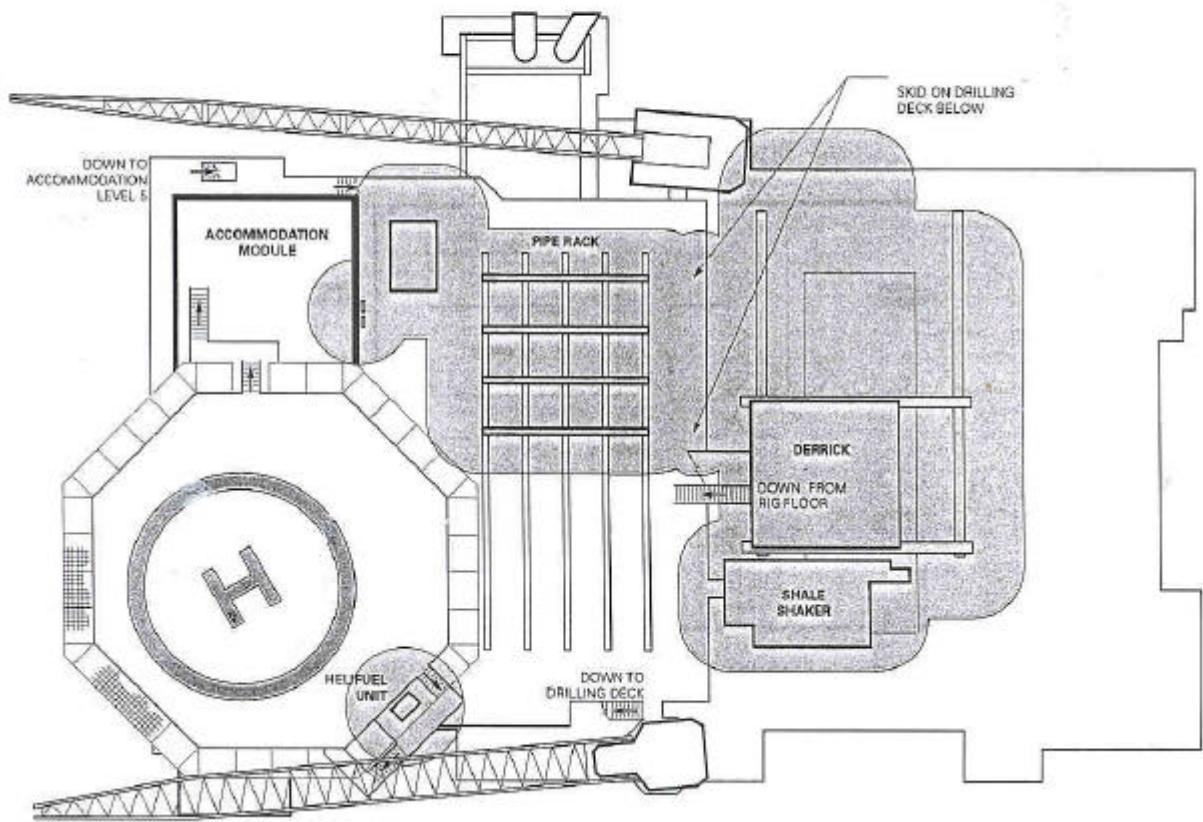
Figure 3: Helideck on an older fixed installation: plan

Fixed platforms may be considered to be the default case for offshore helideck design, where no consideration of helideck motion is required. An example of a helideck on an older fixed installation is shown in figures 3 and 4.

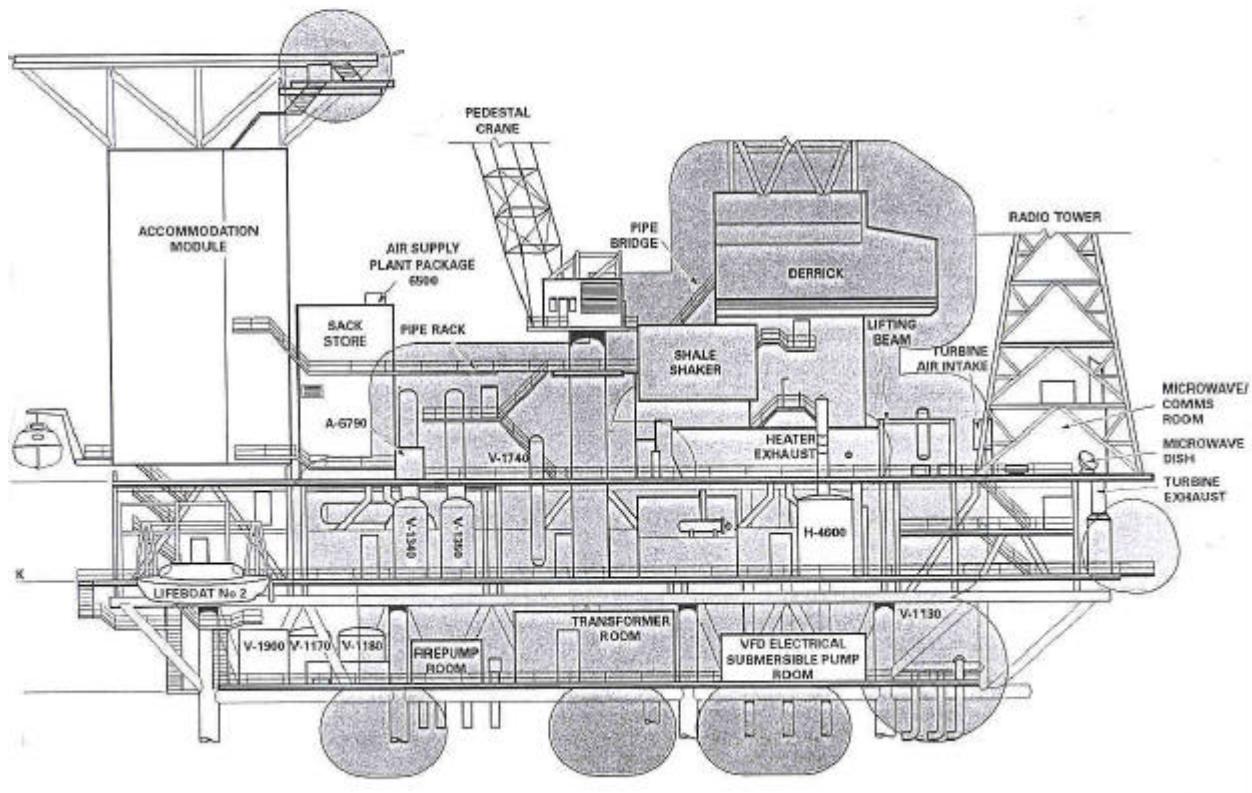
Figure 4: Helideck on an older fixed installation: elevation

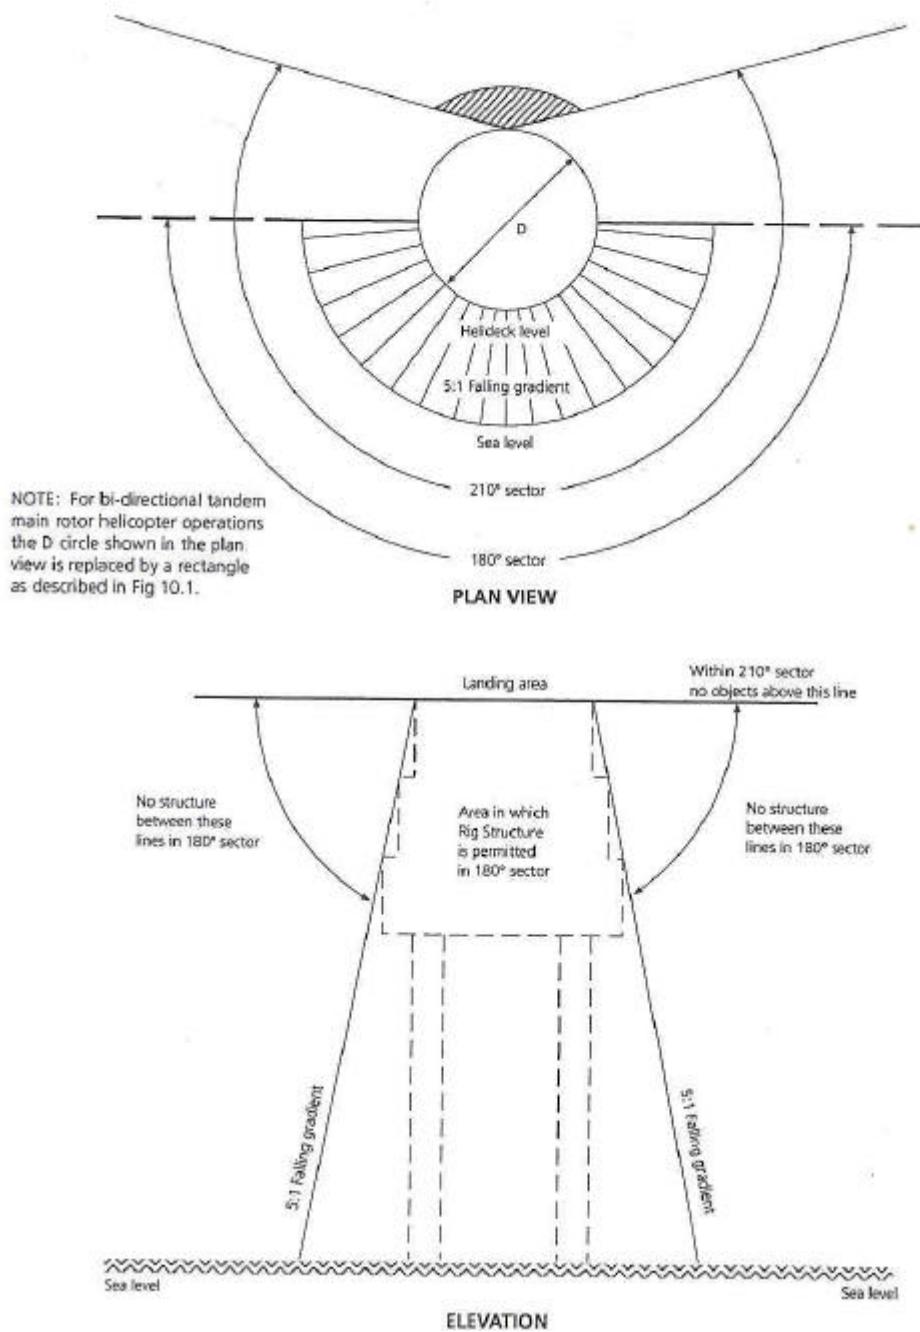
Figure 5: Helideck obstacle-free areas

(from CAP 437 figure 3.2)

An approach and departure sector of 210 degrees extending out for one kilometre must be kept clear of any obstruction more than 250 mm above the level of helideck. Within the remaining 150 degree arc and out to a distance of 0.83D no object should exceed 0.05D high, where D is the overall length of the largest helicopter in use including the rotors. The limits of the obstacle-free and limited obstacle sectors are normally marked by a chevron painted on the helideck. (See figures 5 and 6.)

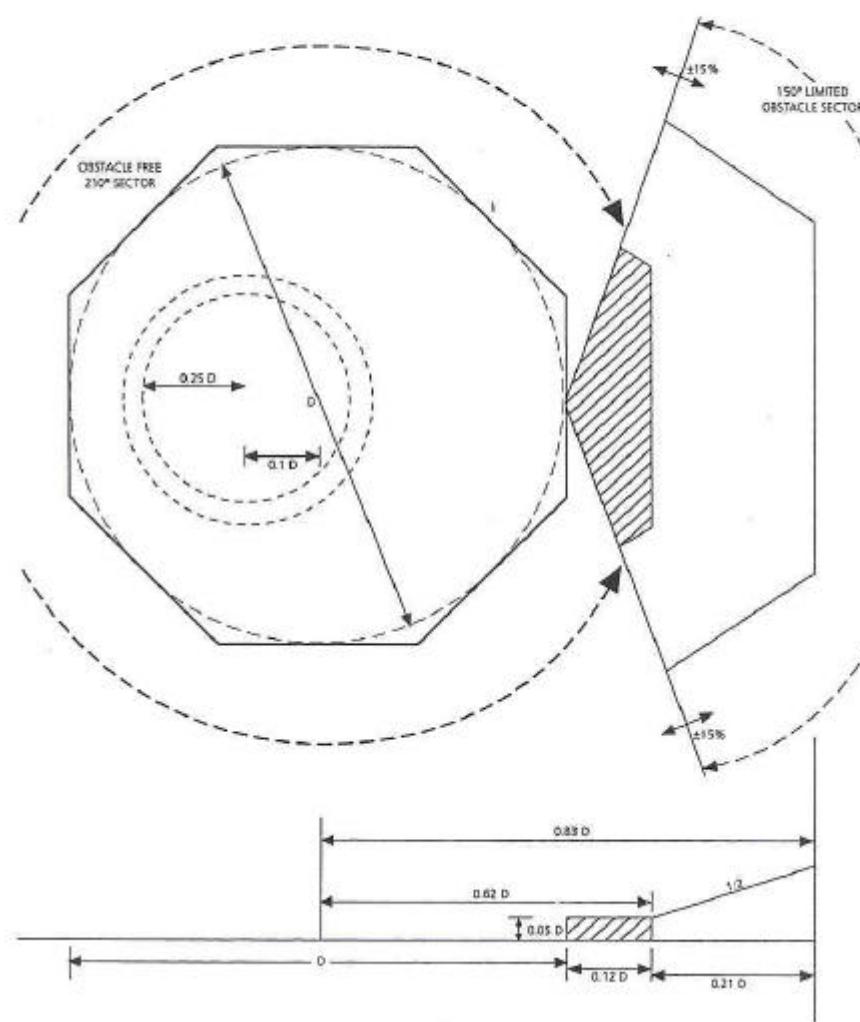
Figure 6: Helideck obstacle limitation sectors

(from CAP 437 figure 3.1)

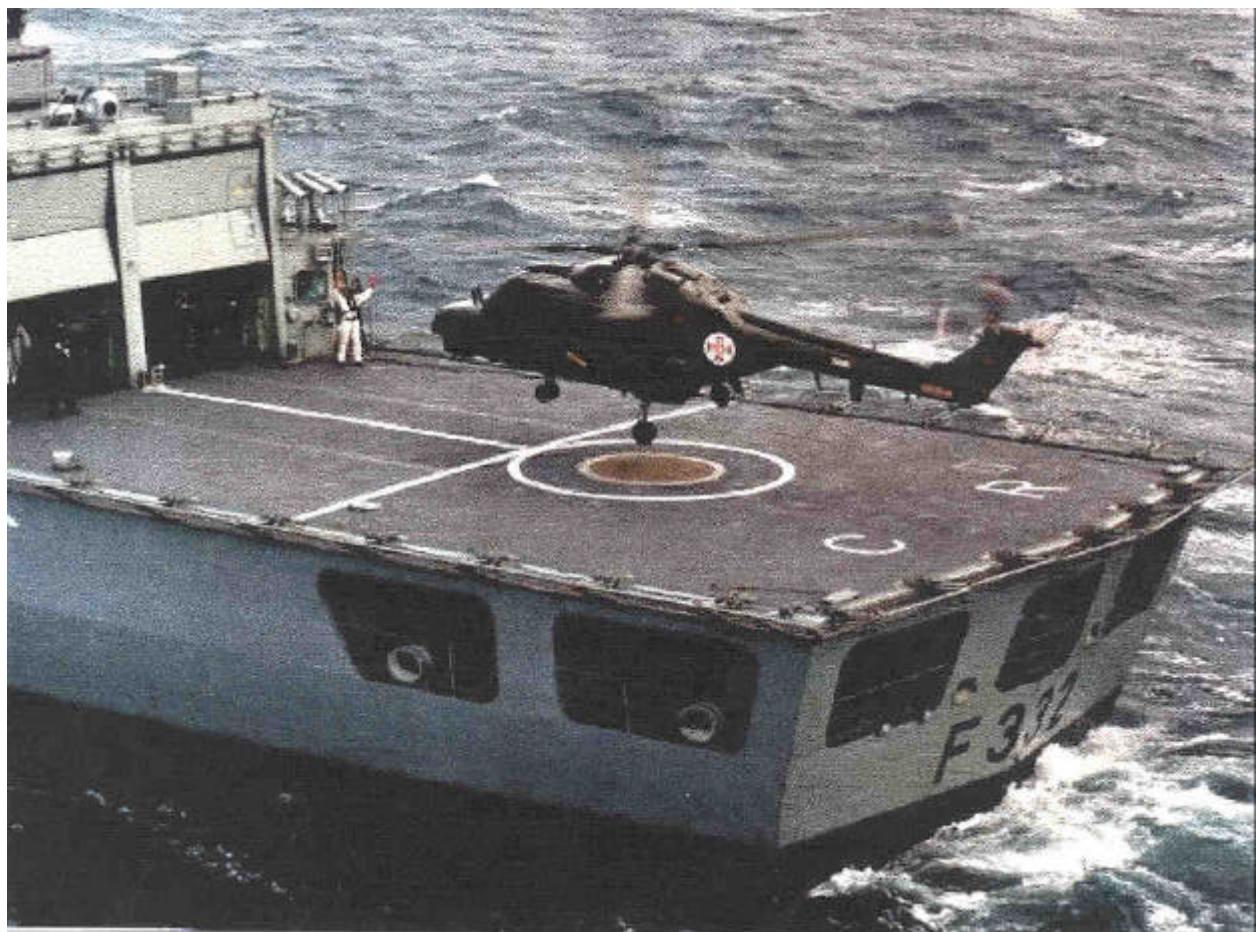
Figure 7: Super Lynx landing on a ship

Due to space constraints, some ships have helicopter operating areas suitable only for winching. Otherwise, areas may be provided directly on the deck structure, either amidships or at the bow or stern. An example of a helicopter landing area on the deck of a vessel is shown in figure 7.

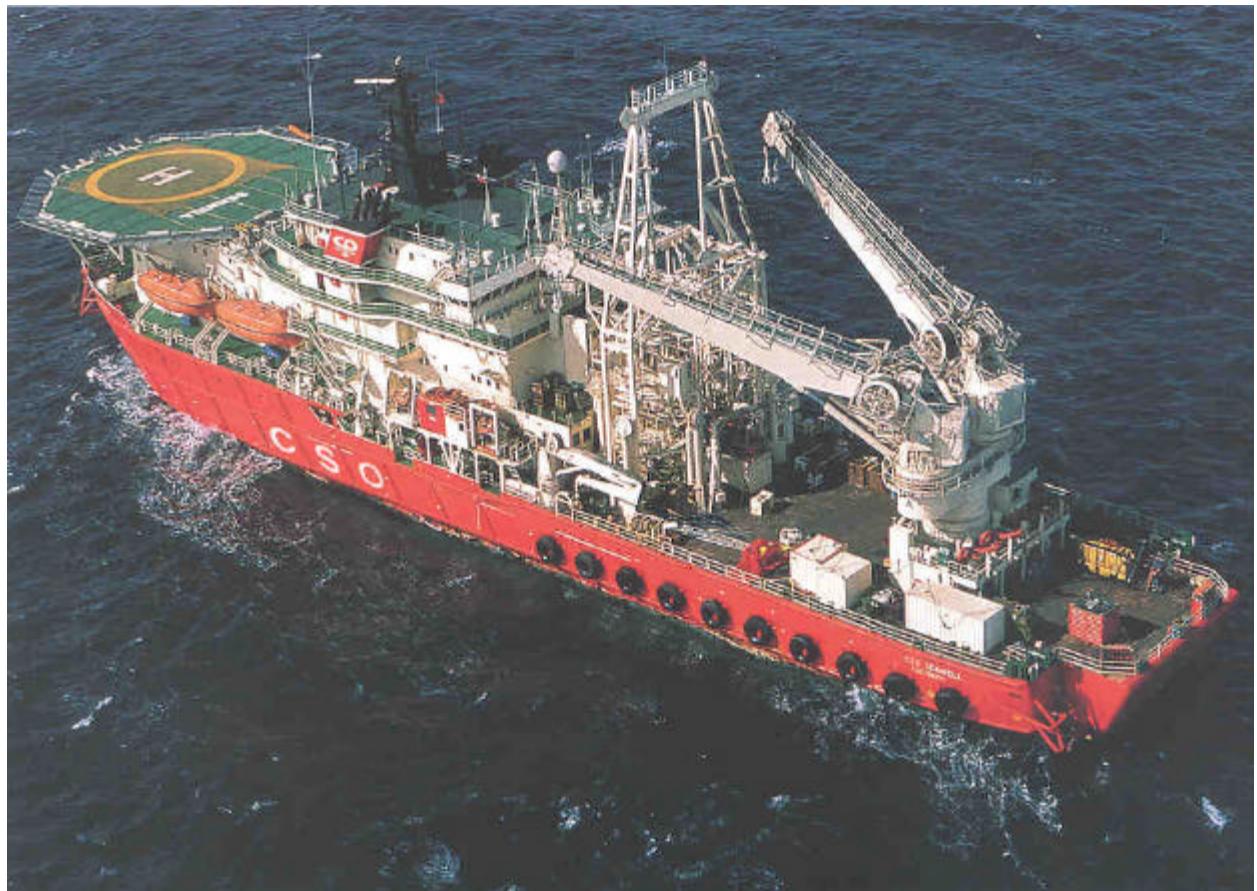
Figure 8: Helideck on a diving support vessel (DSV)

Helicopter landing areas at any location on the deck of a ship are susceptible to wind turbulence compared to raised helidecks, where a relatively unobstructed airflow is possible under the deck. Larger ships that have been purpose-built for offshore use generally have helidecks located above the ship's structure. Similar design and operating criteria apply as for helidecks on offshore installations. An example of a helideck on a diving support vessel is shown in figure 8.

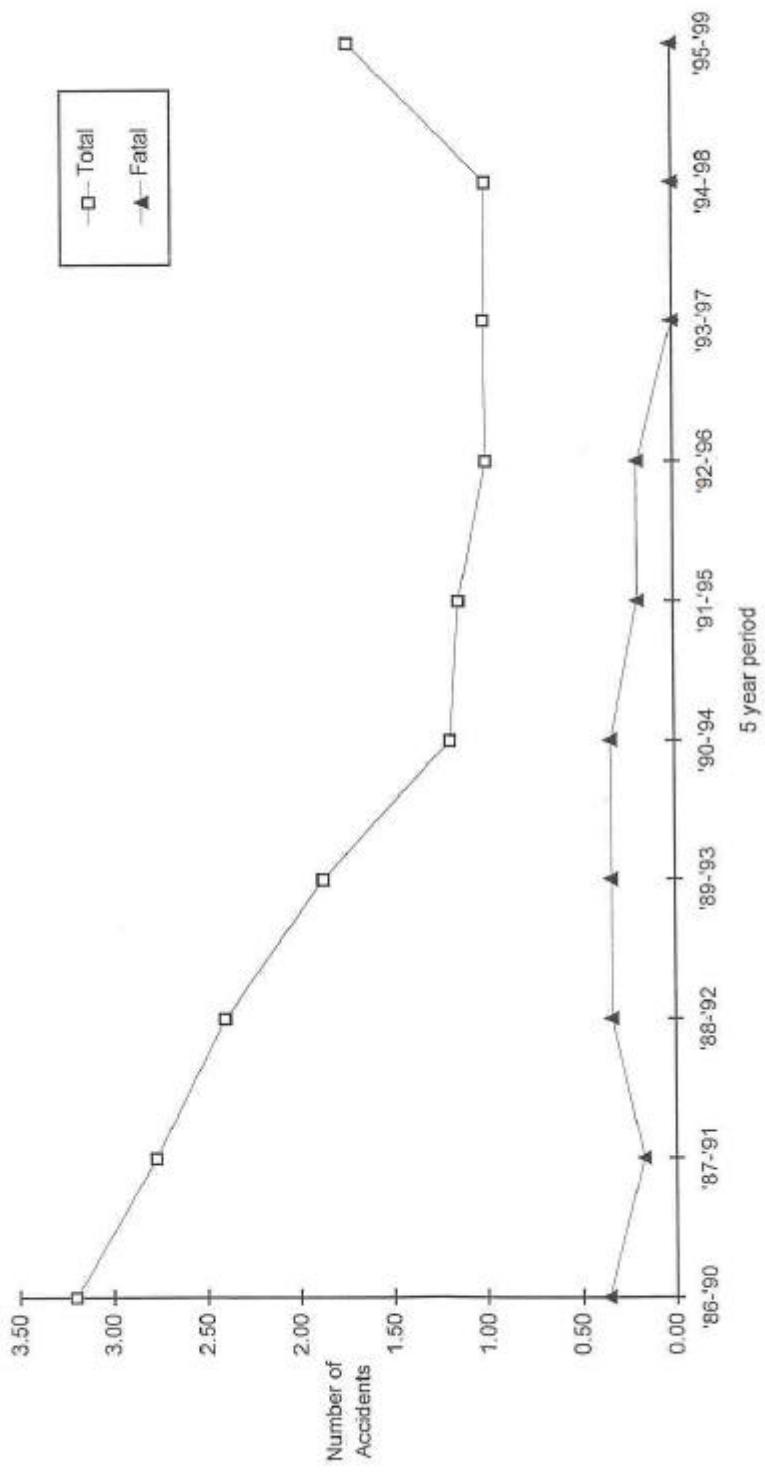
UK REGISTERED MULTI-ENGINED HELICOPTERS IN OFFSHORE OPERATIONS
FIVE YEAR MOVING AVERAGE BASED ON NUMBER OF ACCIDENTS PER 100,000 HOURS FLOWN

Year	Hours Flown (000's)	Flight Stages (000's)	Reportable Accidents		Rate per 100,000 hours flown Total/ Fatal/	Rate per 100,000 flight stages Total/ Fatal/	5 year moving average (per 100,000 hours)	
			Total	Fatal			Total	Fatal
1990	134.3	354.5	3	1	4	2.23	0.74	0.85
1991	117.9	305.5	2	0	0	1.70	-	0.65
1992	104.8	256.0	1	1	10	0.95	0.95	0.39
1993	93.6	219.5	1	0	0	1.07	-	0.46
1994	94.2	217.1	0	0	0	-	-	-
1995	102.1	234.3	2	0	0	1.96	-	0.85
1996	102.0	226.6	1	0	0	0.98	-	0.44
1997	101.0	209.7	1	0	0	0.99	-	0.48
1998	96.7	205.7	1	0	0	1.03	-	0.49
1999	82.3	191.5	3	0	0	3.65	-	1.57
							-	1.72
